Catchpit Safety Review

Stage 2: Risk Assessment

DOCUMENT CONTROL SHEET**Client:** Auckland Council**Report Title:** Catchpit Safety Review – Stage 2: Risk Assessment**Ref:** 3-awc38.02

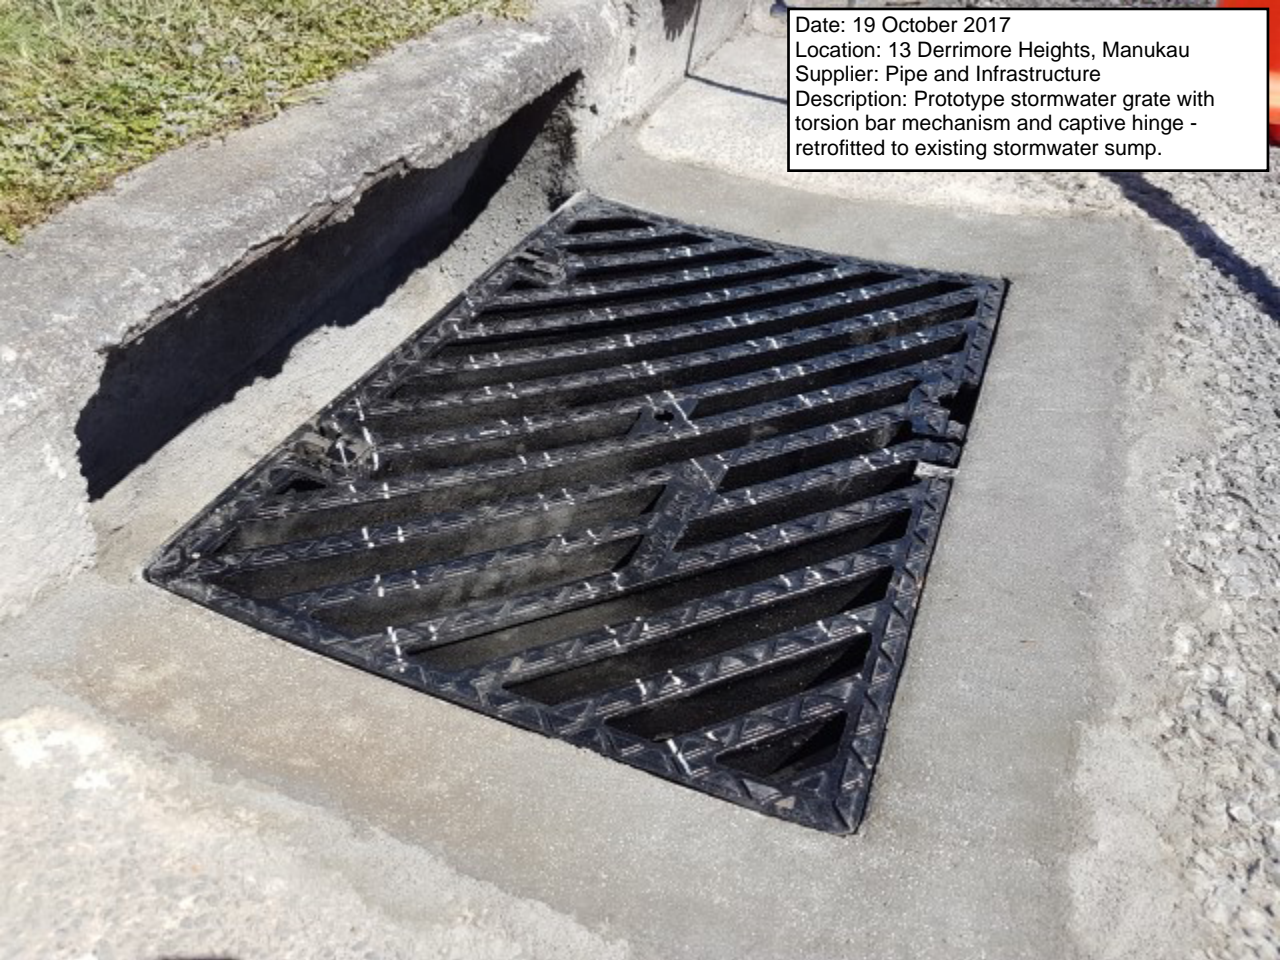
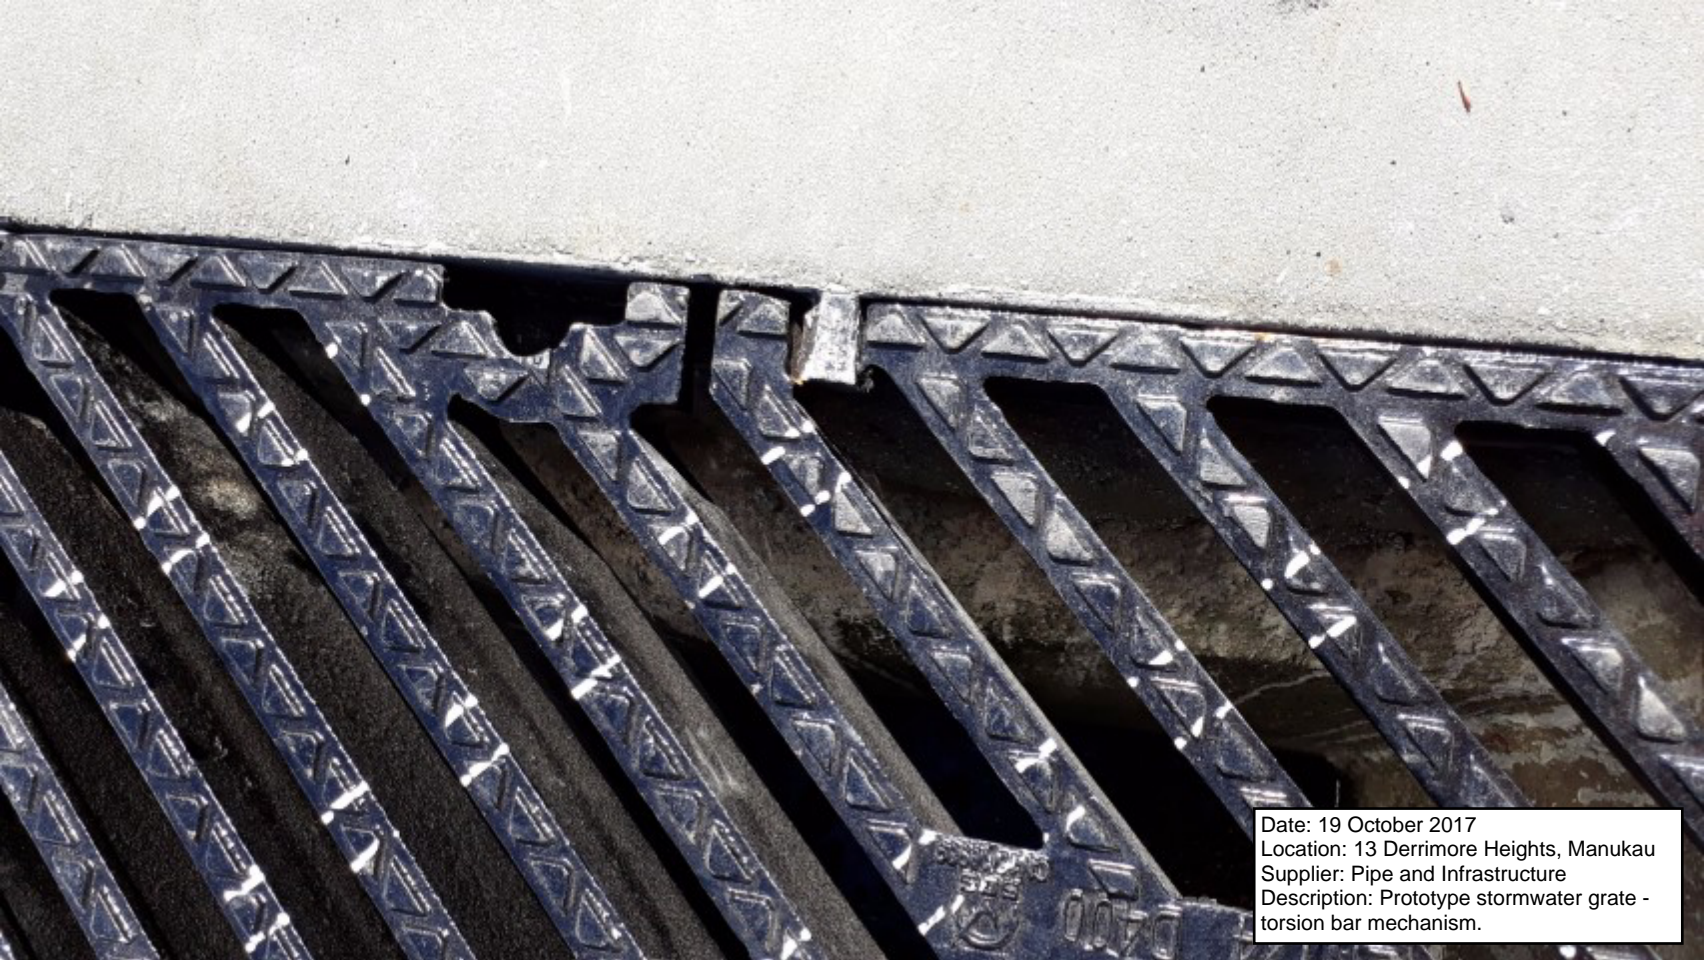
Description: Prototype stormwater grate with torsion bar mechanism and captive hinge - retrofitted to existing stormwater sump.

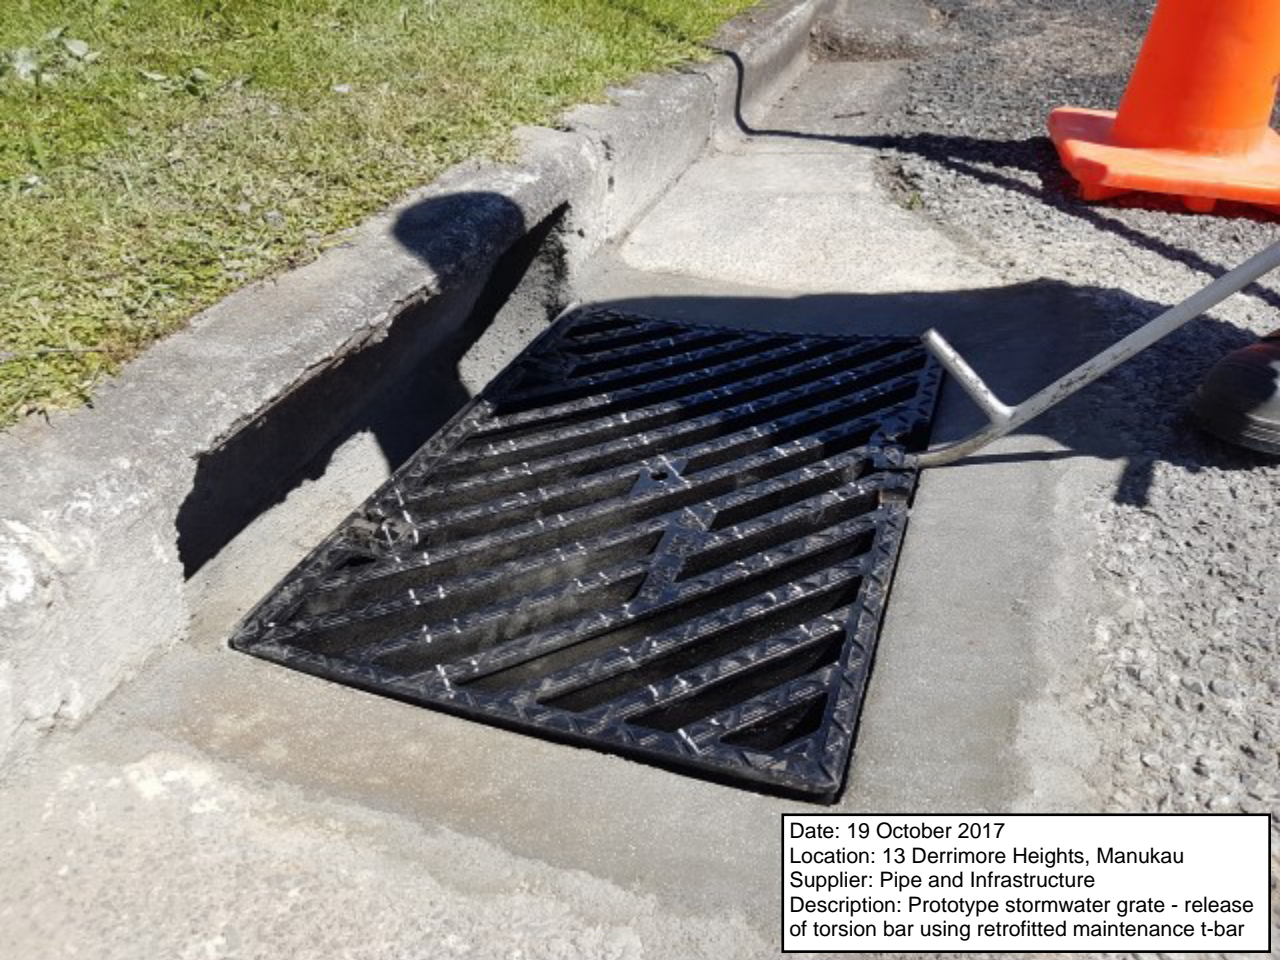
Date: 19 October 2017
Location: 13 Derrimore Heights, Manukau
Supplier: Pipe and Infrastructure
Description: Prototype stormwater grate -
torsion bar mechanism.

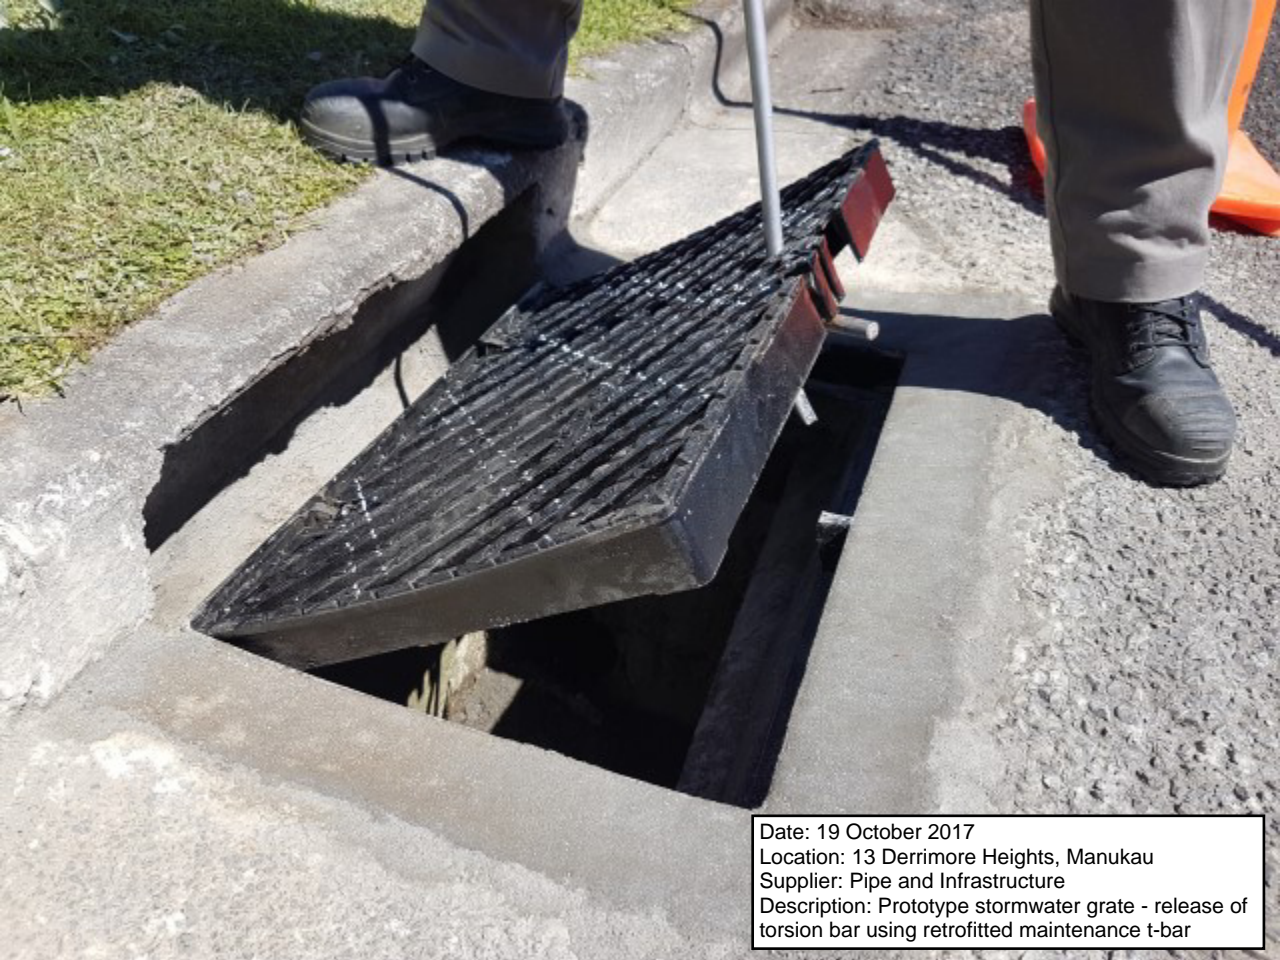
Date: 19 October 2017
Location: 13 Derrimore Heights, Manukau
Supplier: Pipe and Infrastructure
Description: Prototype stormwater grate - release
of torsion bar using retrofitted maintenance t-bar

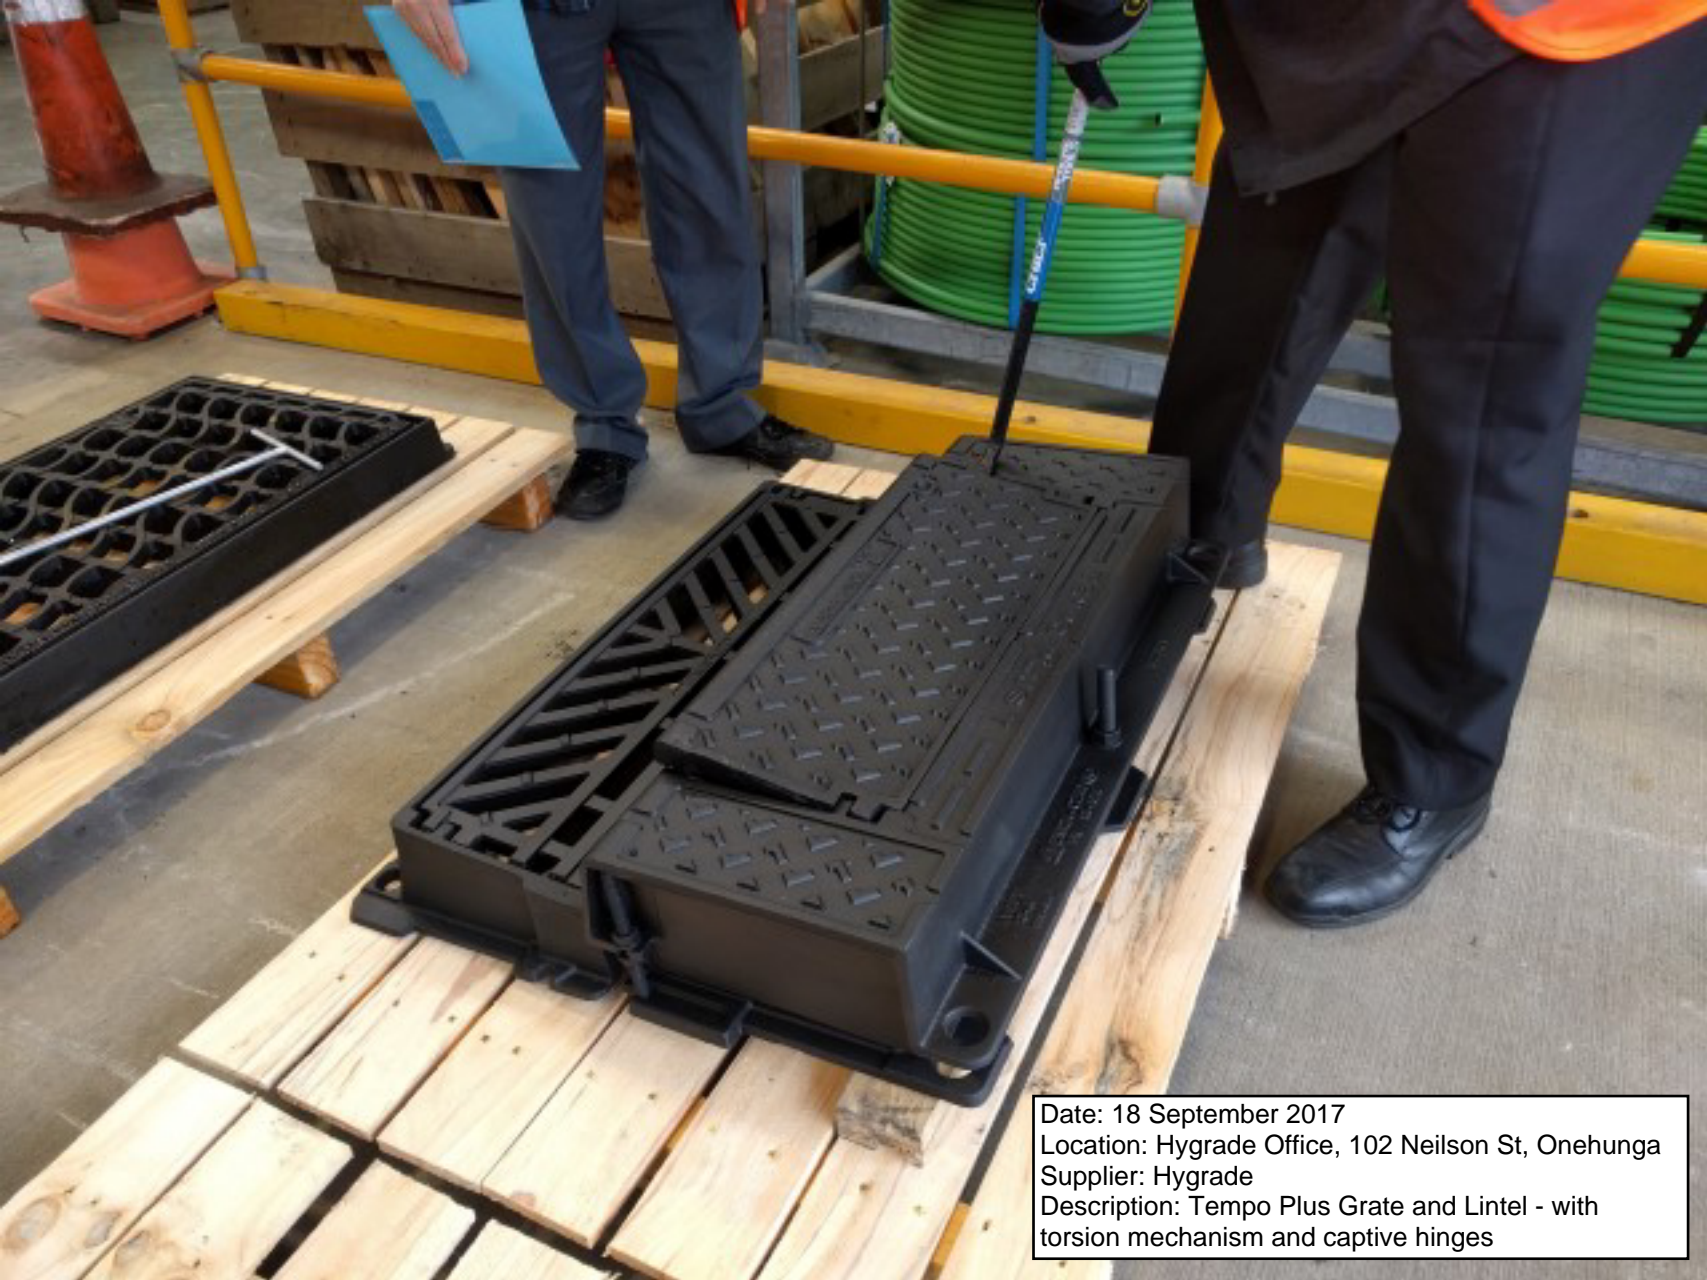
Description: Prototype stormwater grate - retrofitted to existing stormwater sump. installed adjacent to existing standard catchpit

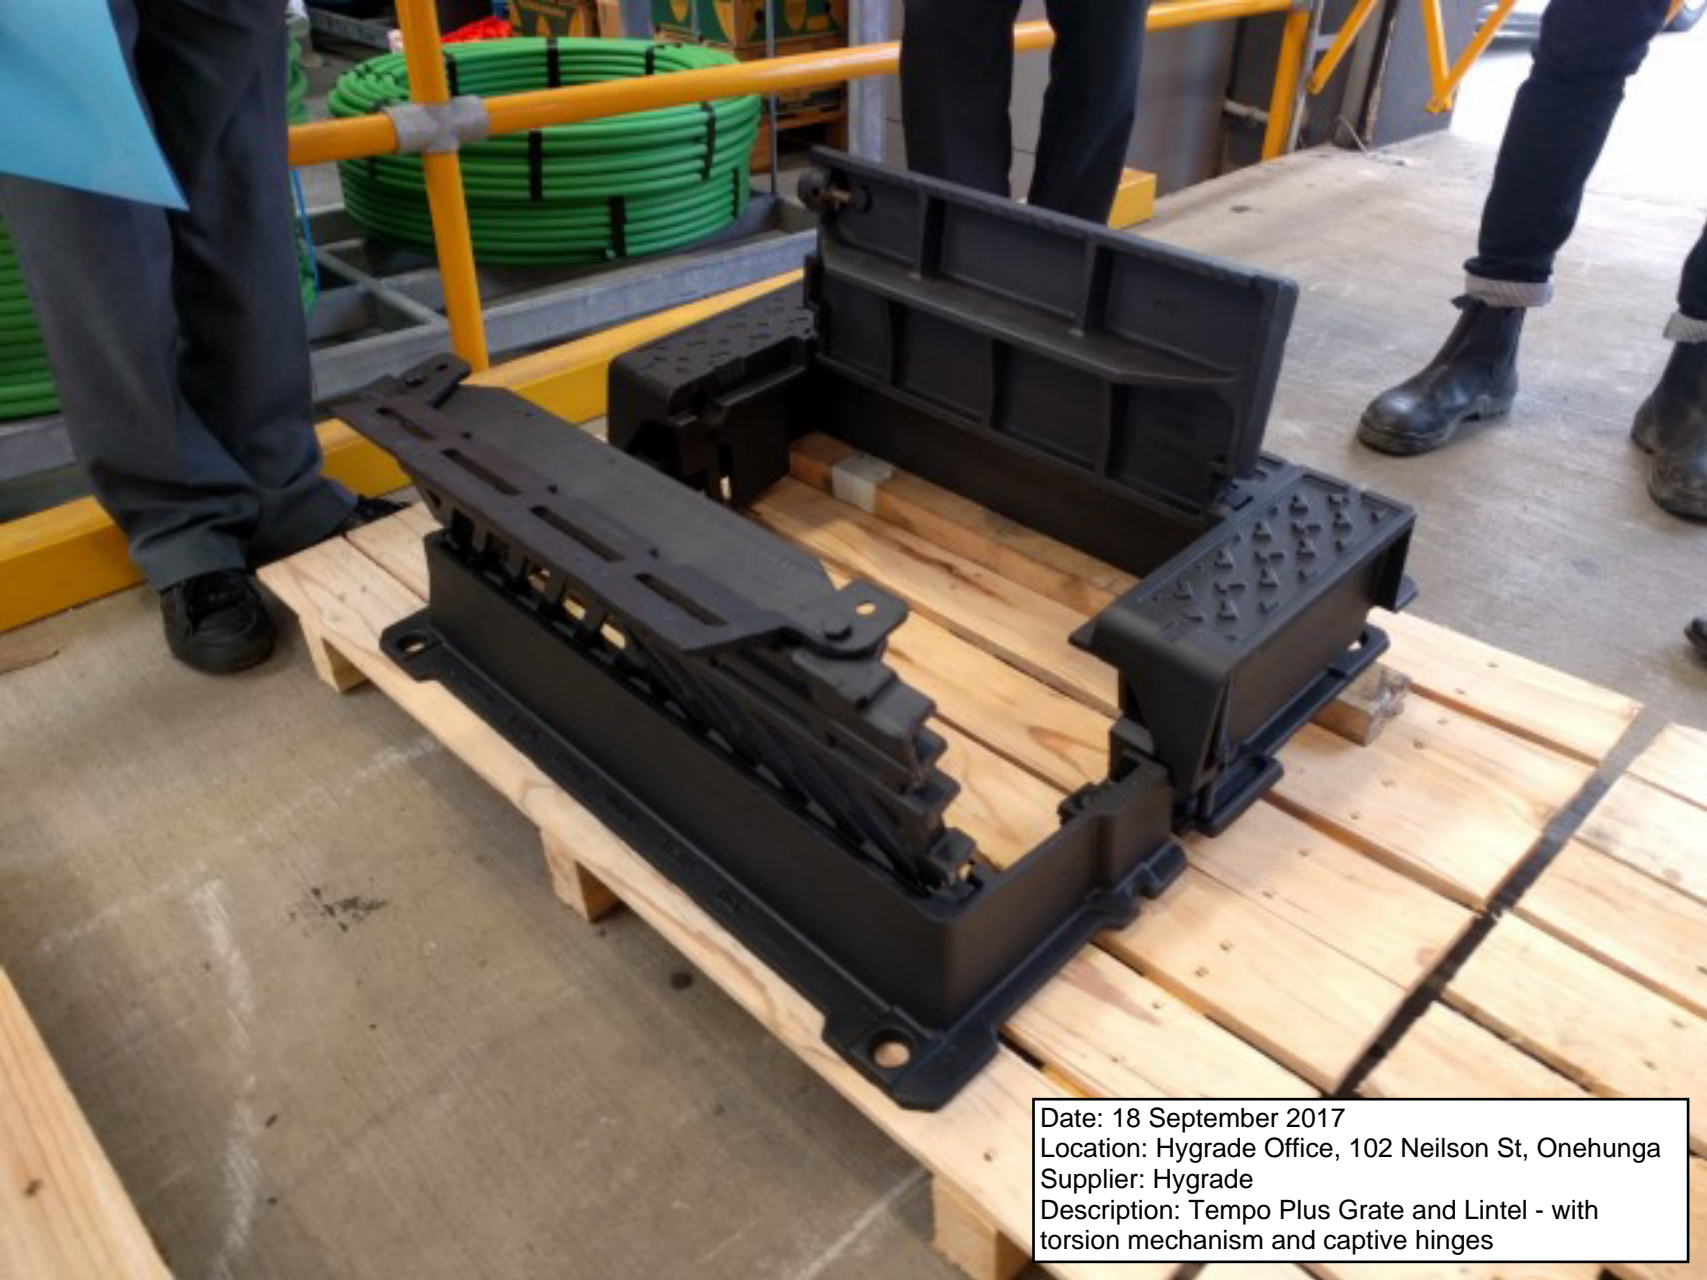
Date: 18 September 2017
Location: Hygrade Office, 102 Neilson St, Onehunga
Supplier: Hygrade
Description: Tempo Plus Grate and Lintel - with
torsion mechanism and captive hinges

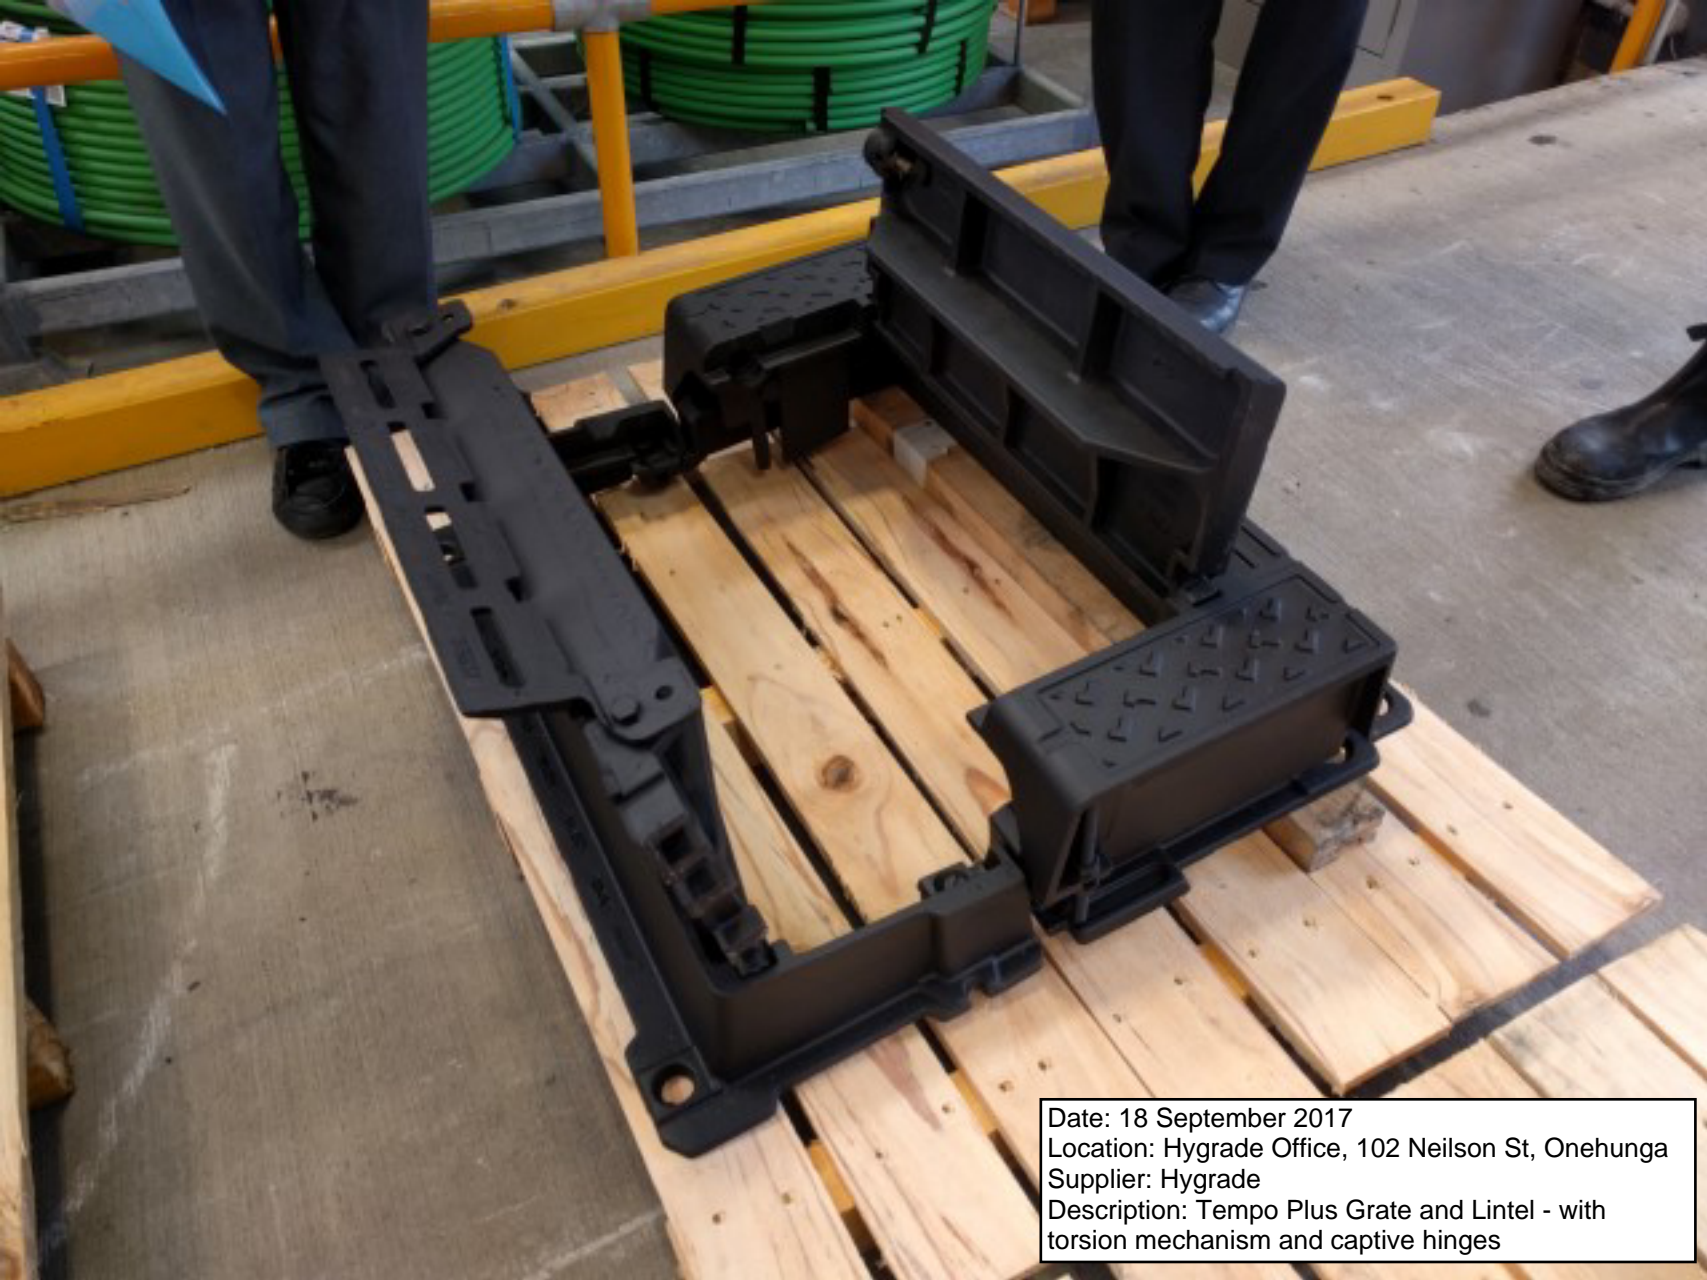
Date: 18 September 2017
Location: Hygrade Office, 102 Neilson St, Onehunga
Supplier: Hygrade
Description: Tempo Plus Grate and Lintel - with
torsion mechanism and captive hinges

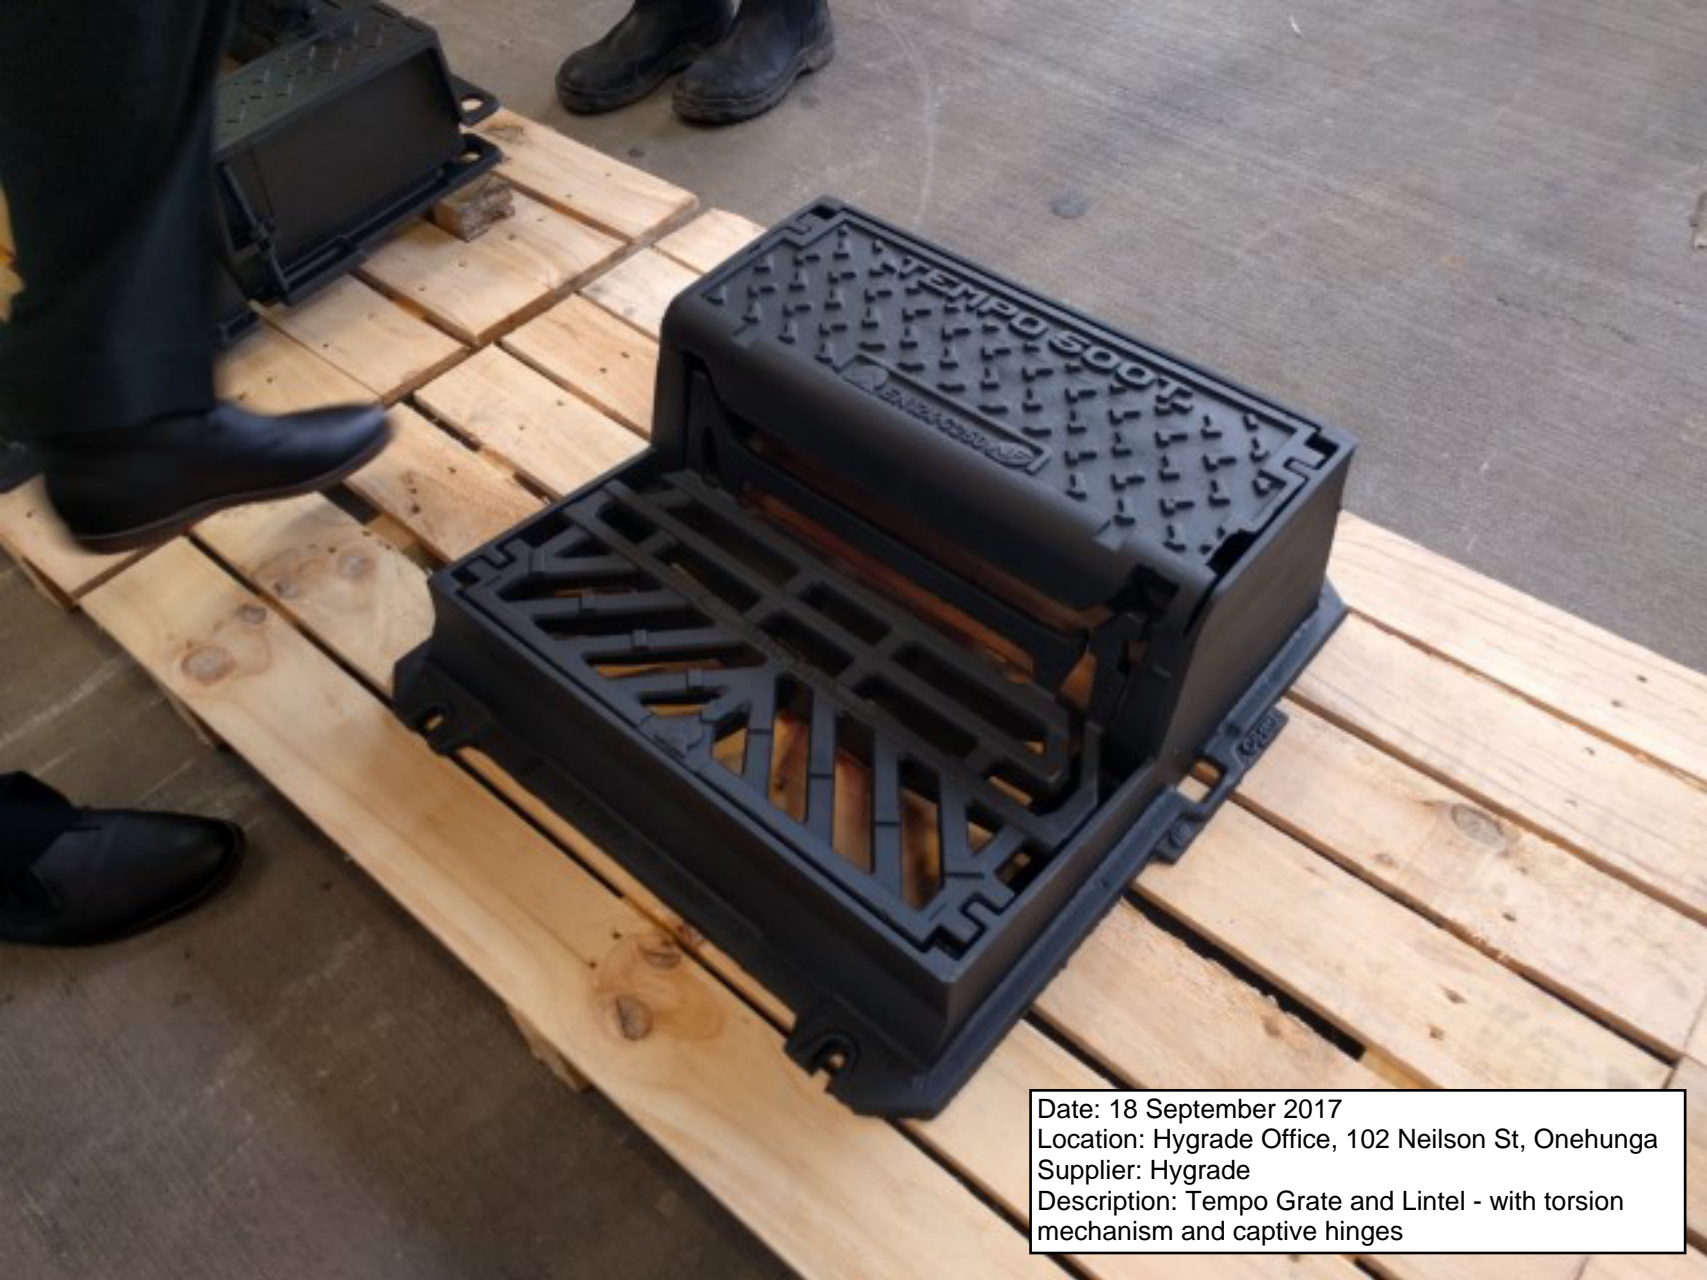
Date: 18 September 2017
Location: Hygrade Office, 102 Neilson St, Onehunga
Supplier: Hygrade
Description: Tempo Plus Grate and Lintel - with
torsion mechanism and captive hinges

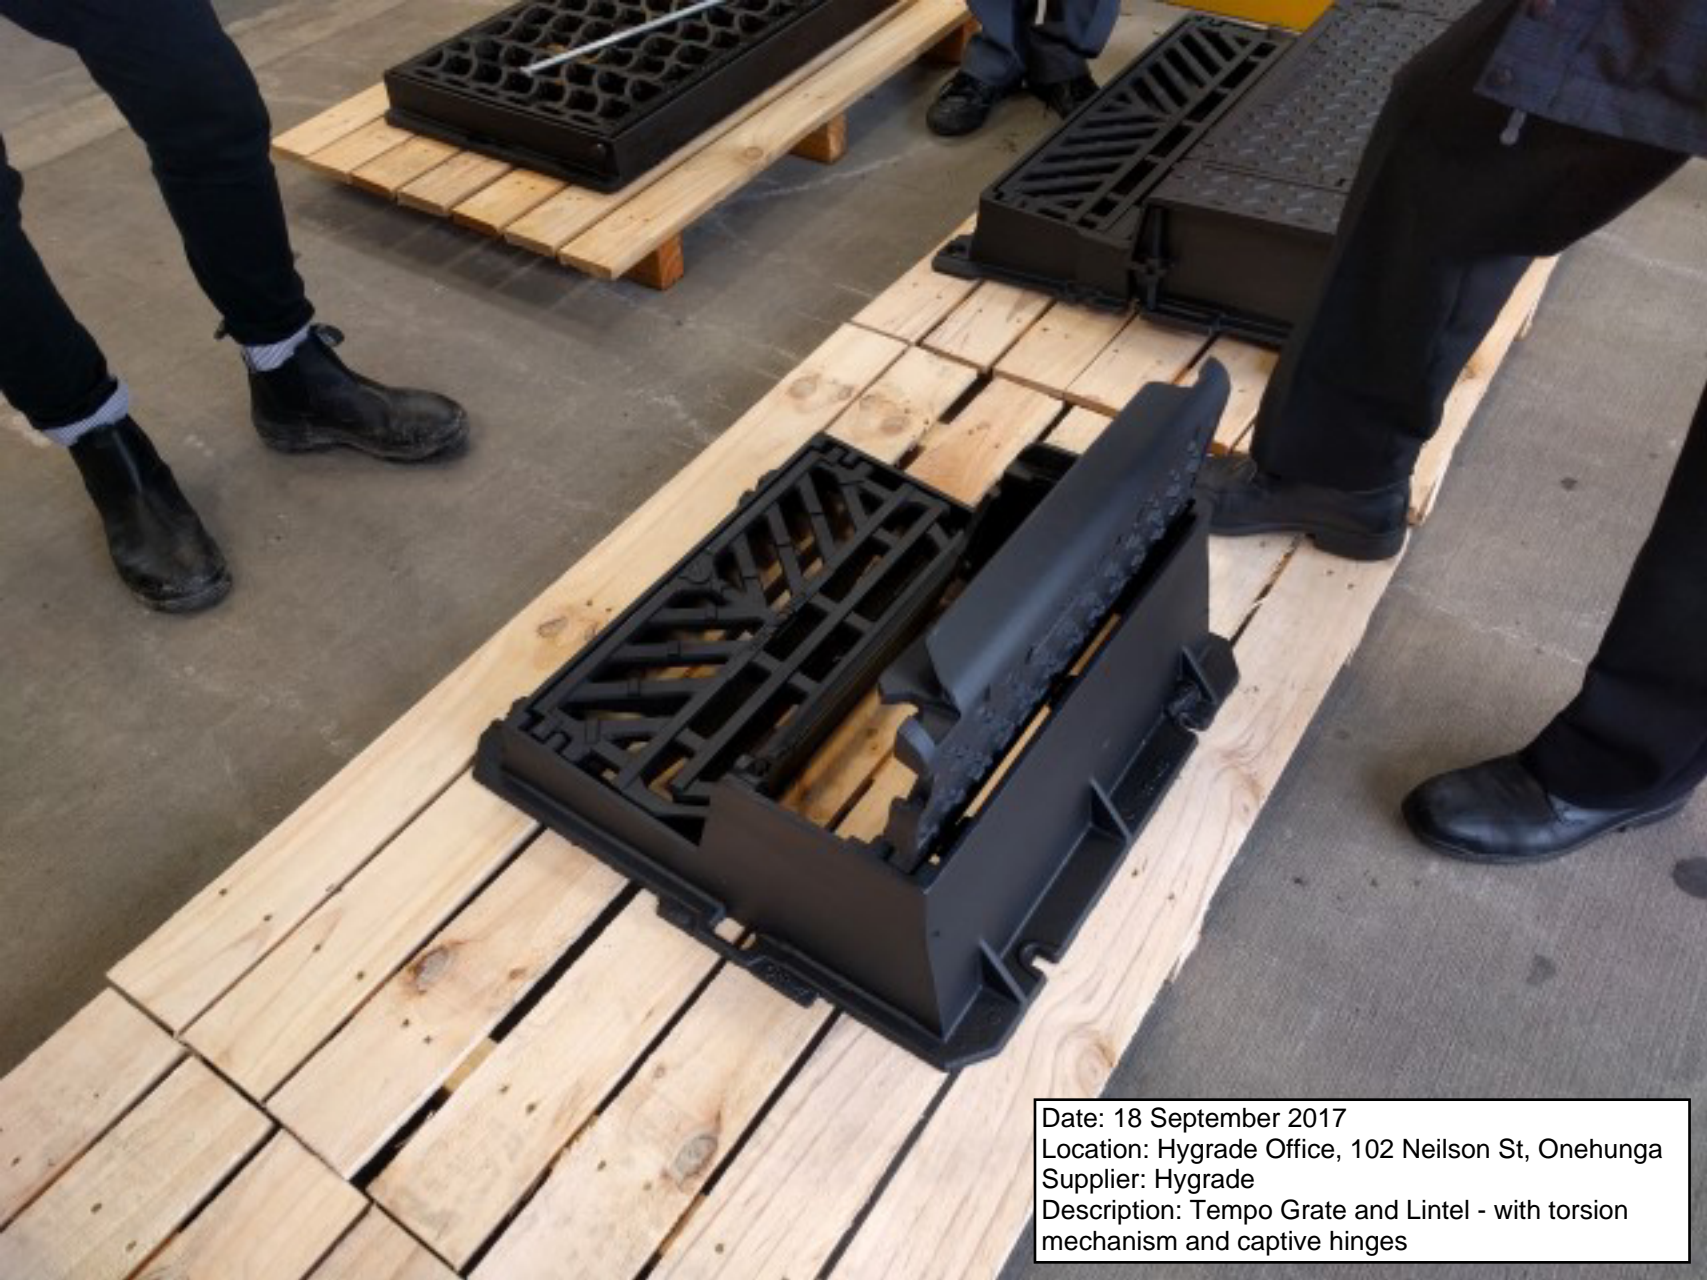
Date: 18 September 2017
Location: Hygrade Office, 102 Neilson St, Onehunga
Supplier: Hygrade
Description: Tempo Grate and Lintel - with torsion mechanism and captive hinges

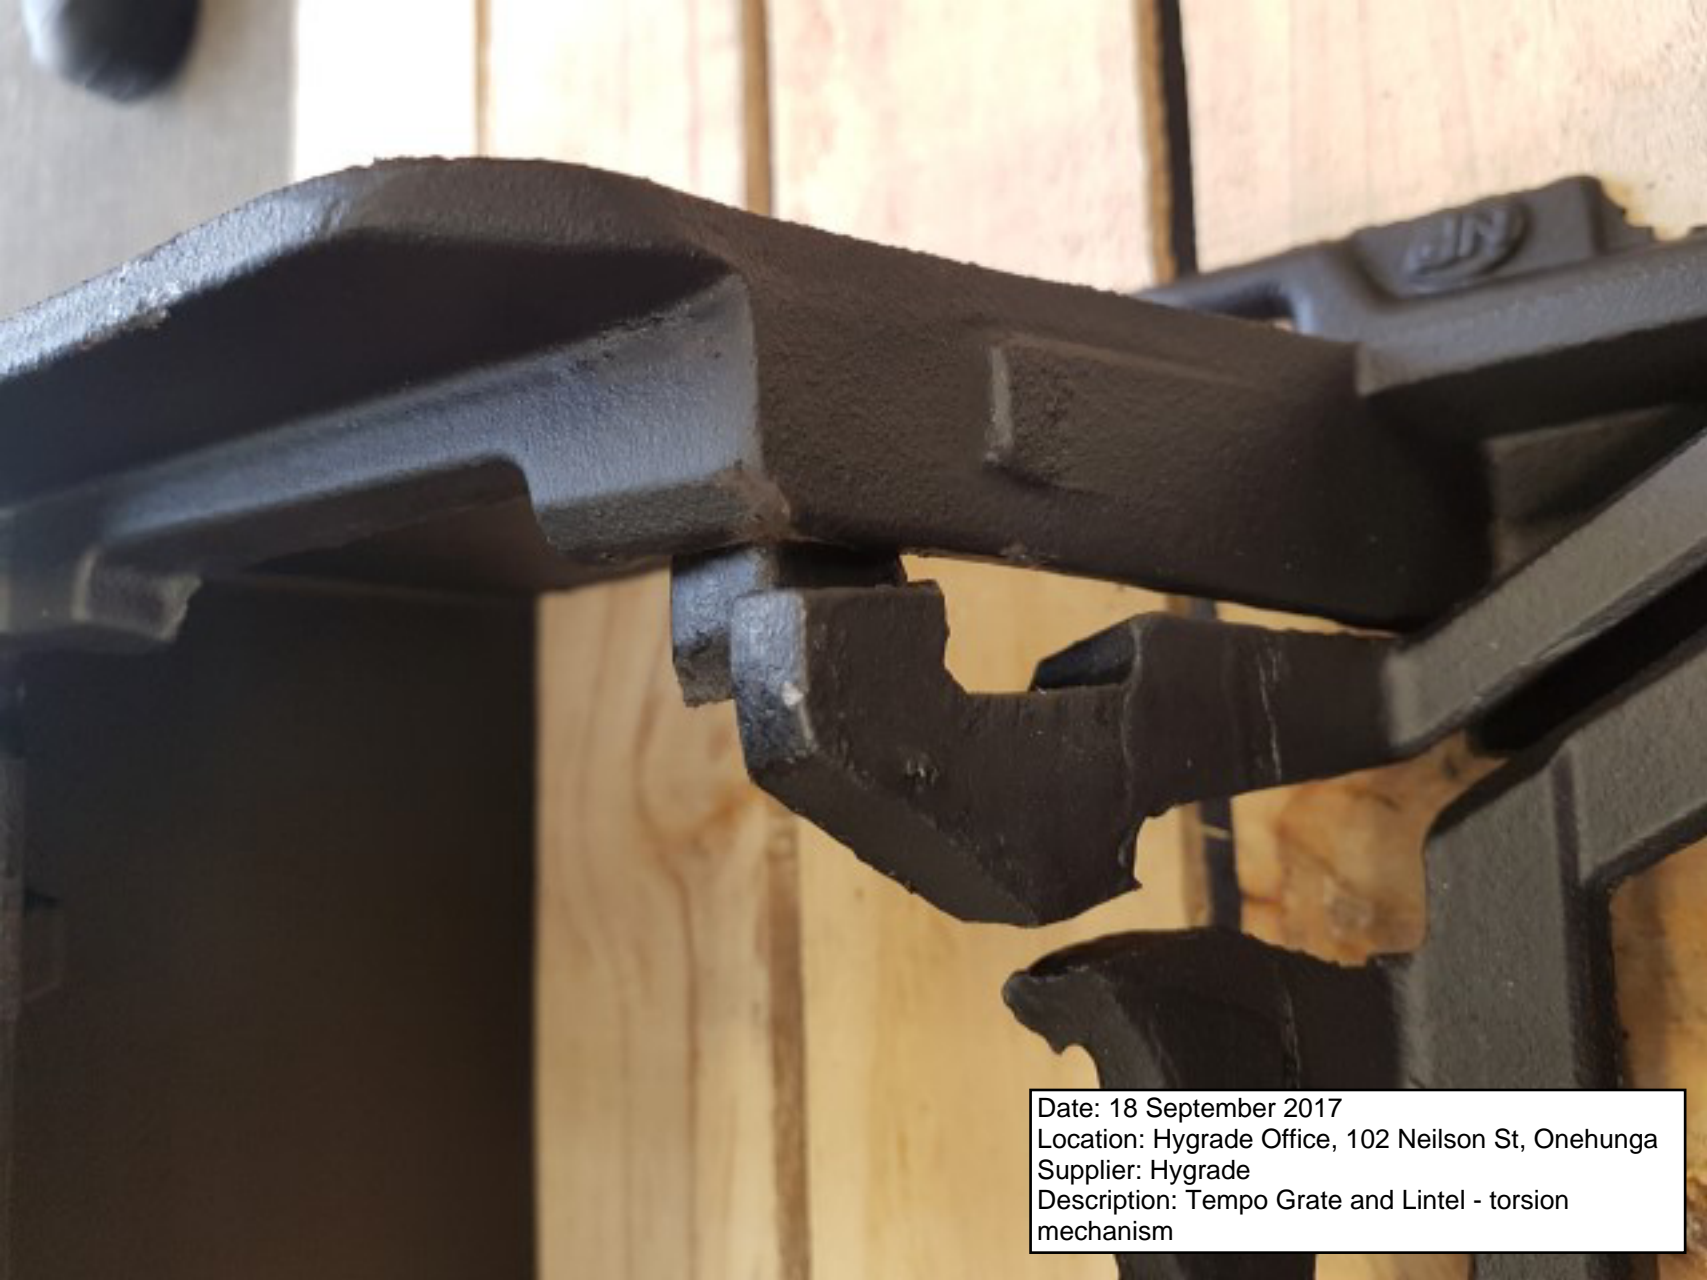
Date: 18 September 2017
Location: Hygrade Office, 102 Neilson St, Onehunga
Supplier: Hygrade
Description: Tempo Grate and Lintel - with torsion mechanism and captive hinges

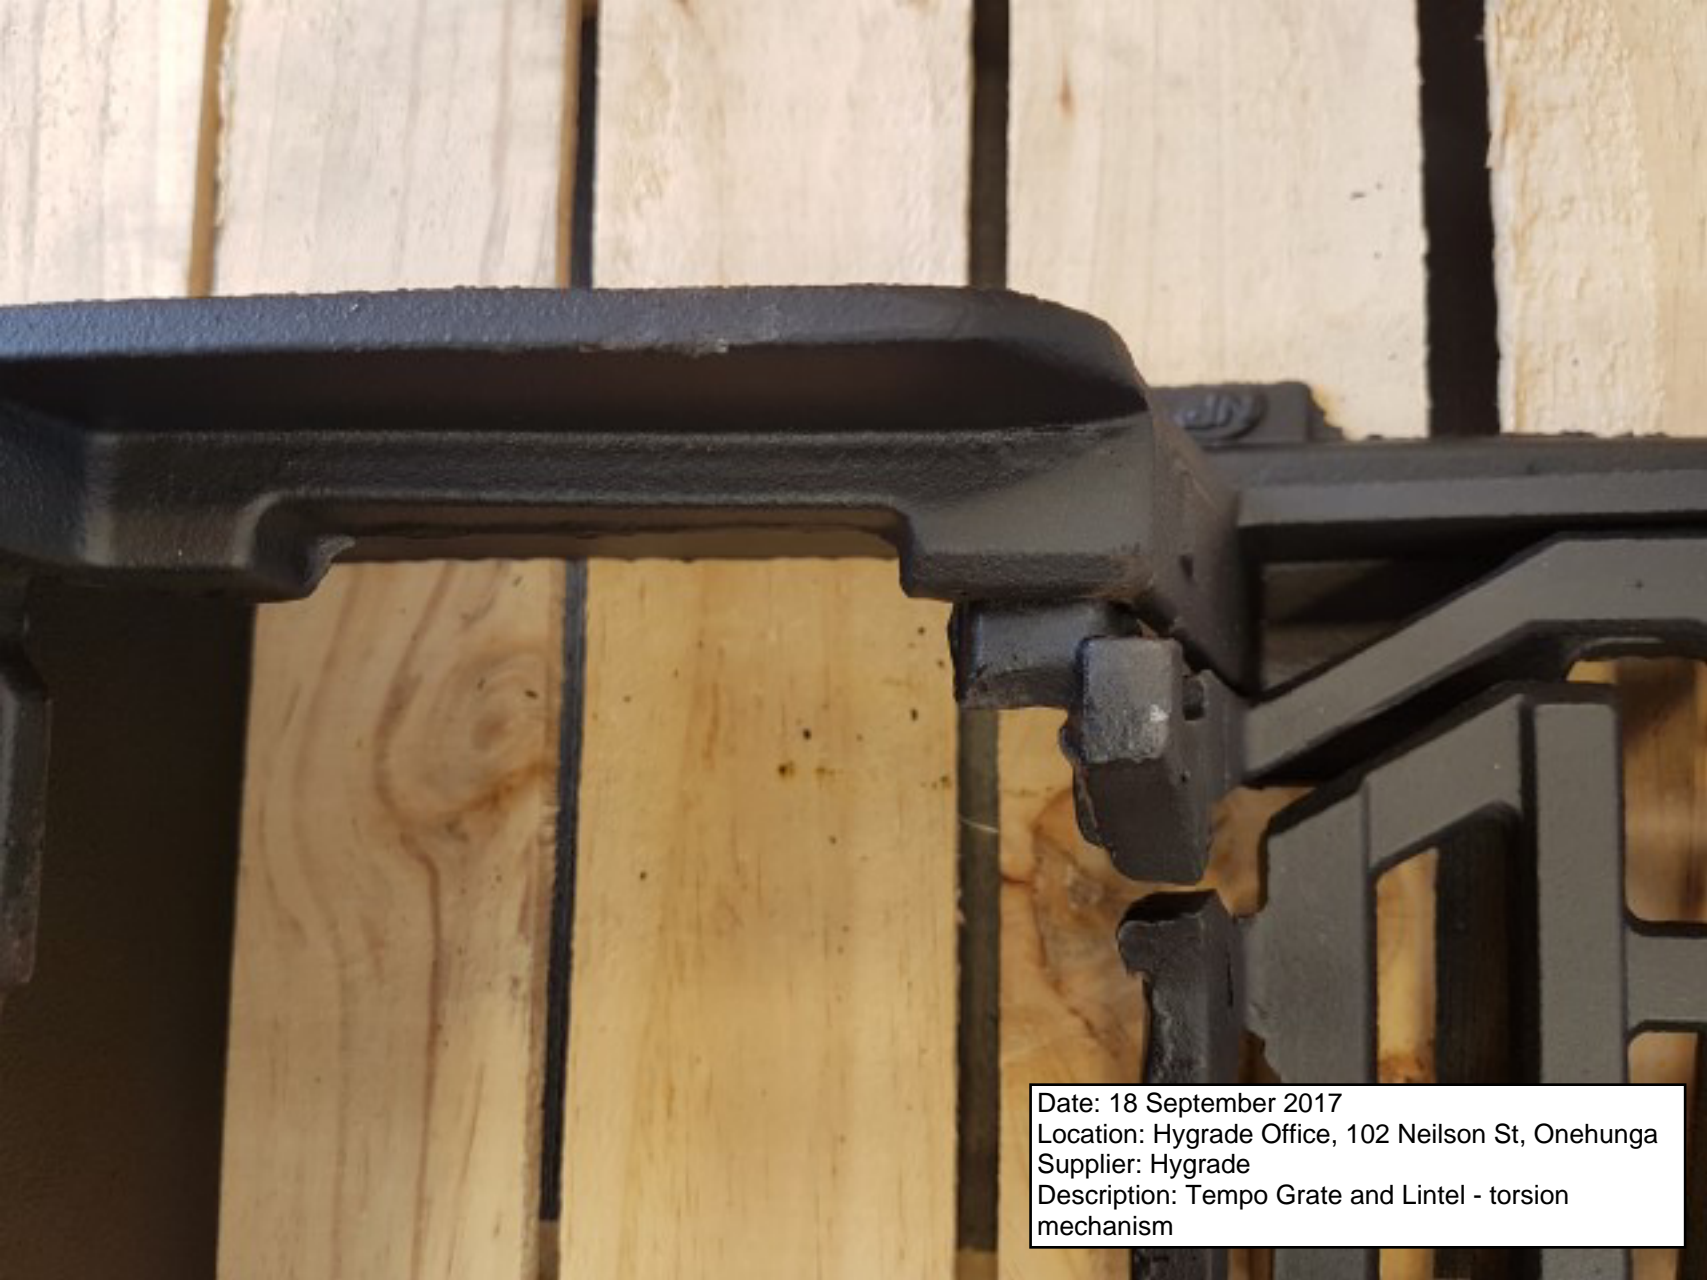
Description: Tempo Grate and Lintel - torsion mechanism

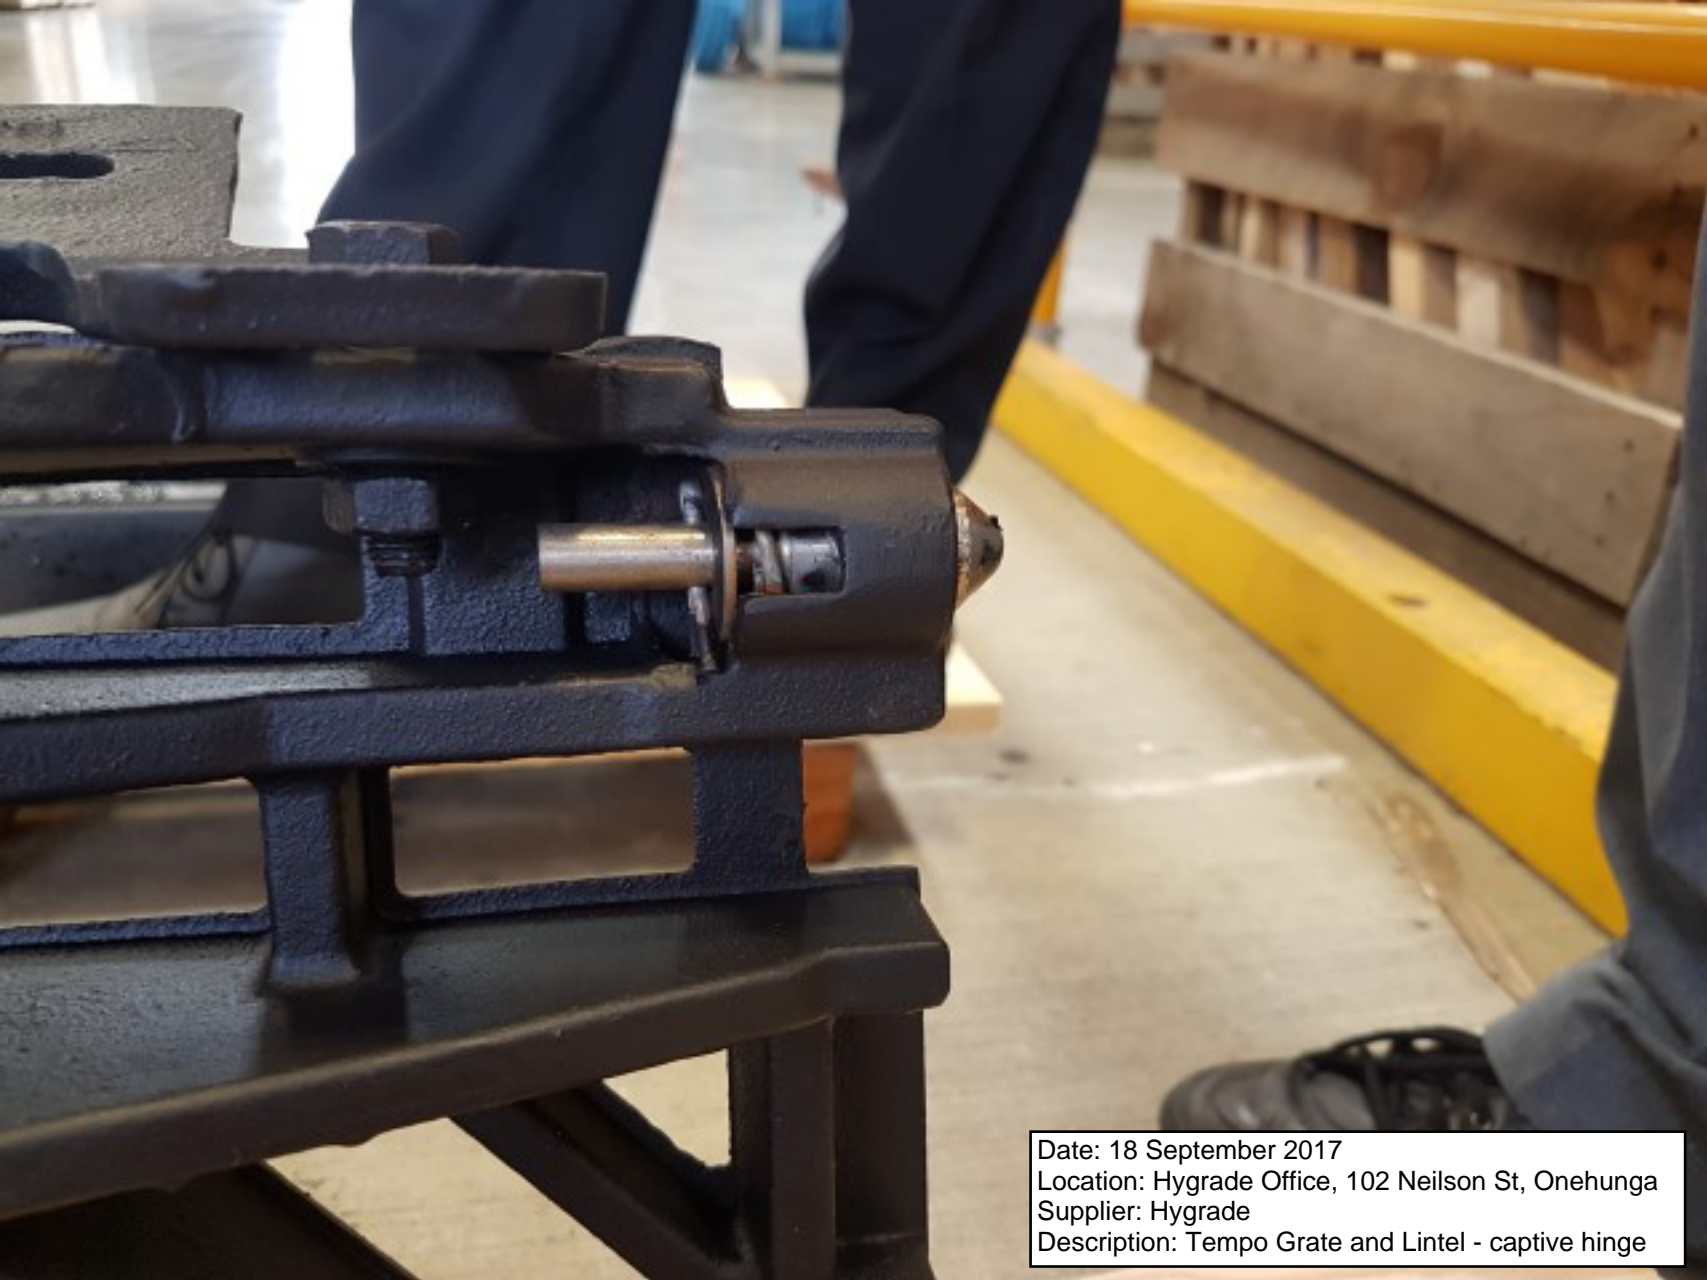
Date: 18 September 2017
Location: Hygrade Office, 102 Neilson St, Onehunga
Supplier: Hygrade
Description: Tempo Grate and Lintel - captive hinge
