Catchpit Safety Review

Stage 2: Risk Assessment

DOCUMENT CONTROL SHEET**Client:** Auckland Council**Report Title:** Catchpit Safety Review – Stage 2: Risk Assessment**Ref:** 3-awc38.02

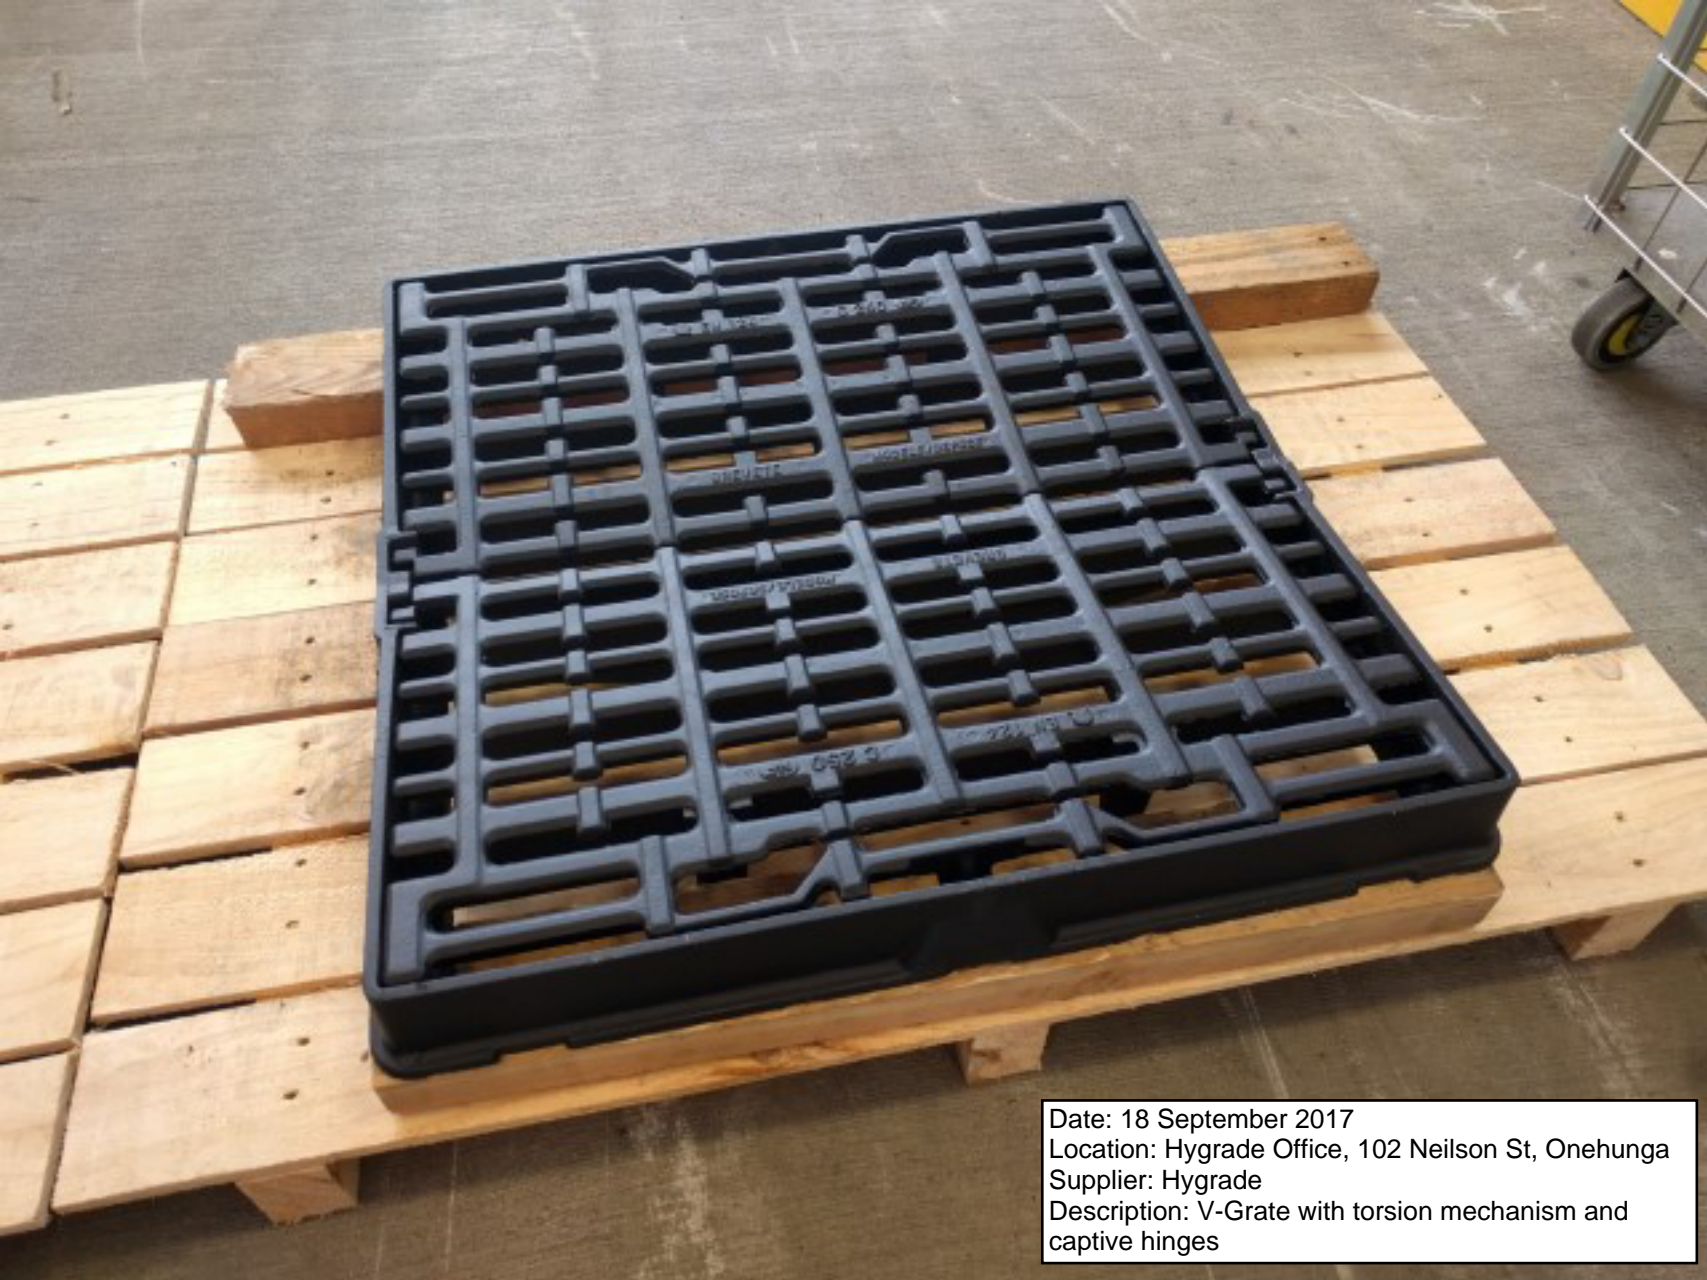
Date: 18 September 2017
Location: Hygrade Office, 102 Neilson St, Onehunga
Supplier: Hygrade
Description: V-Grate with torsion mechanism and captive hinges

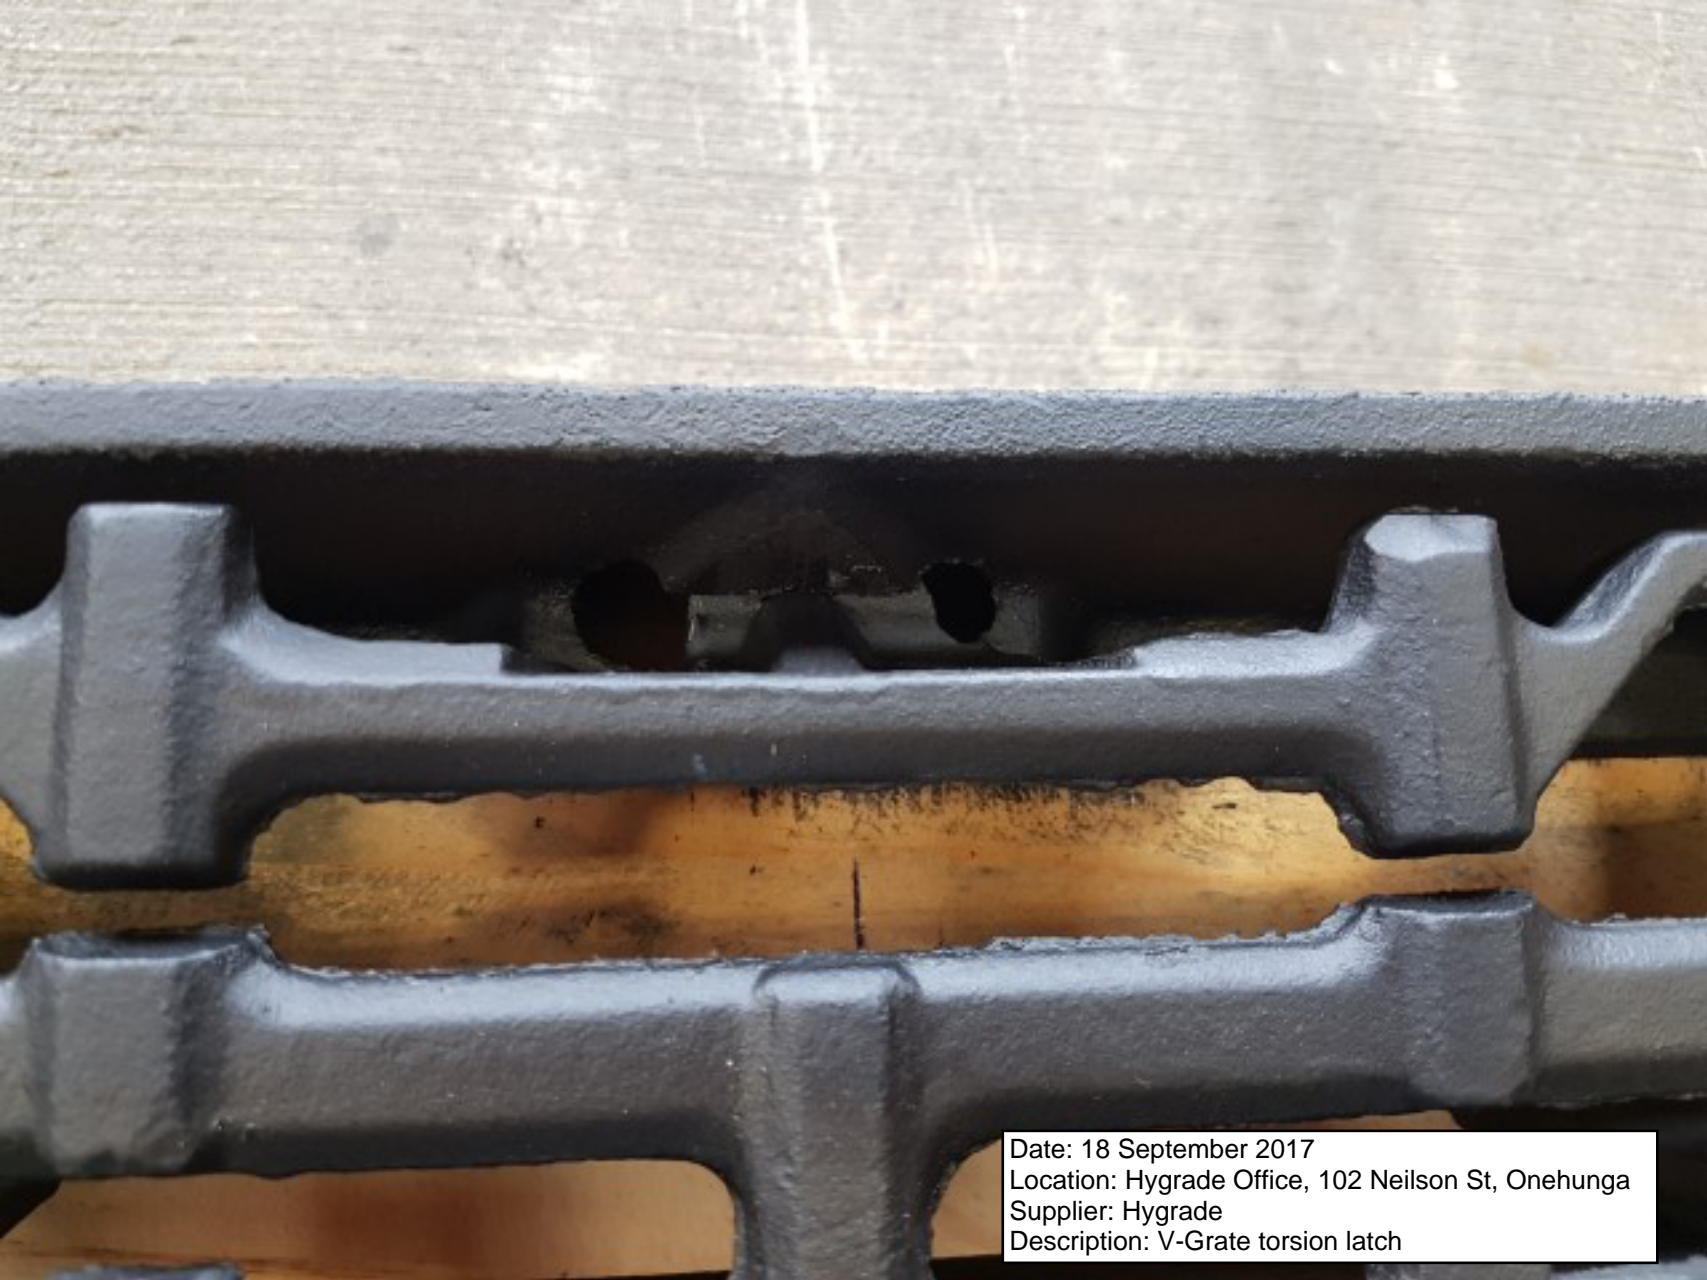
Date: 18 September 2017
Location: Hygrade Office, 102 Neilson St, Onehunga
Supplier: Hygrade
Description: V-Grate with torsion mechanism and captive hinges

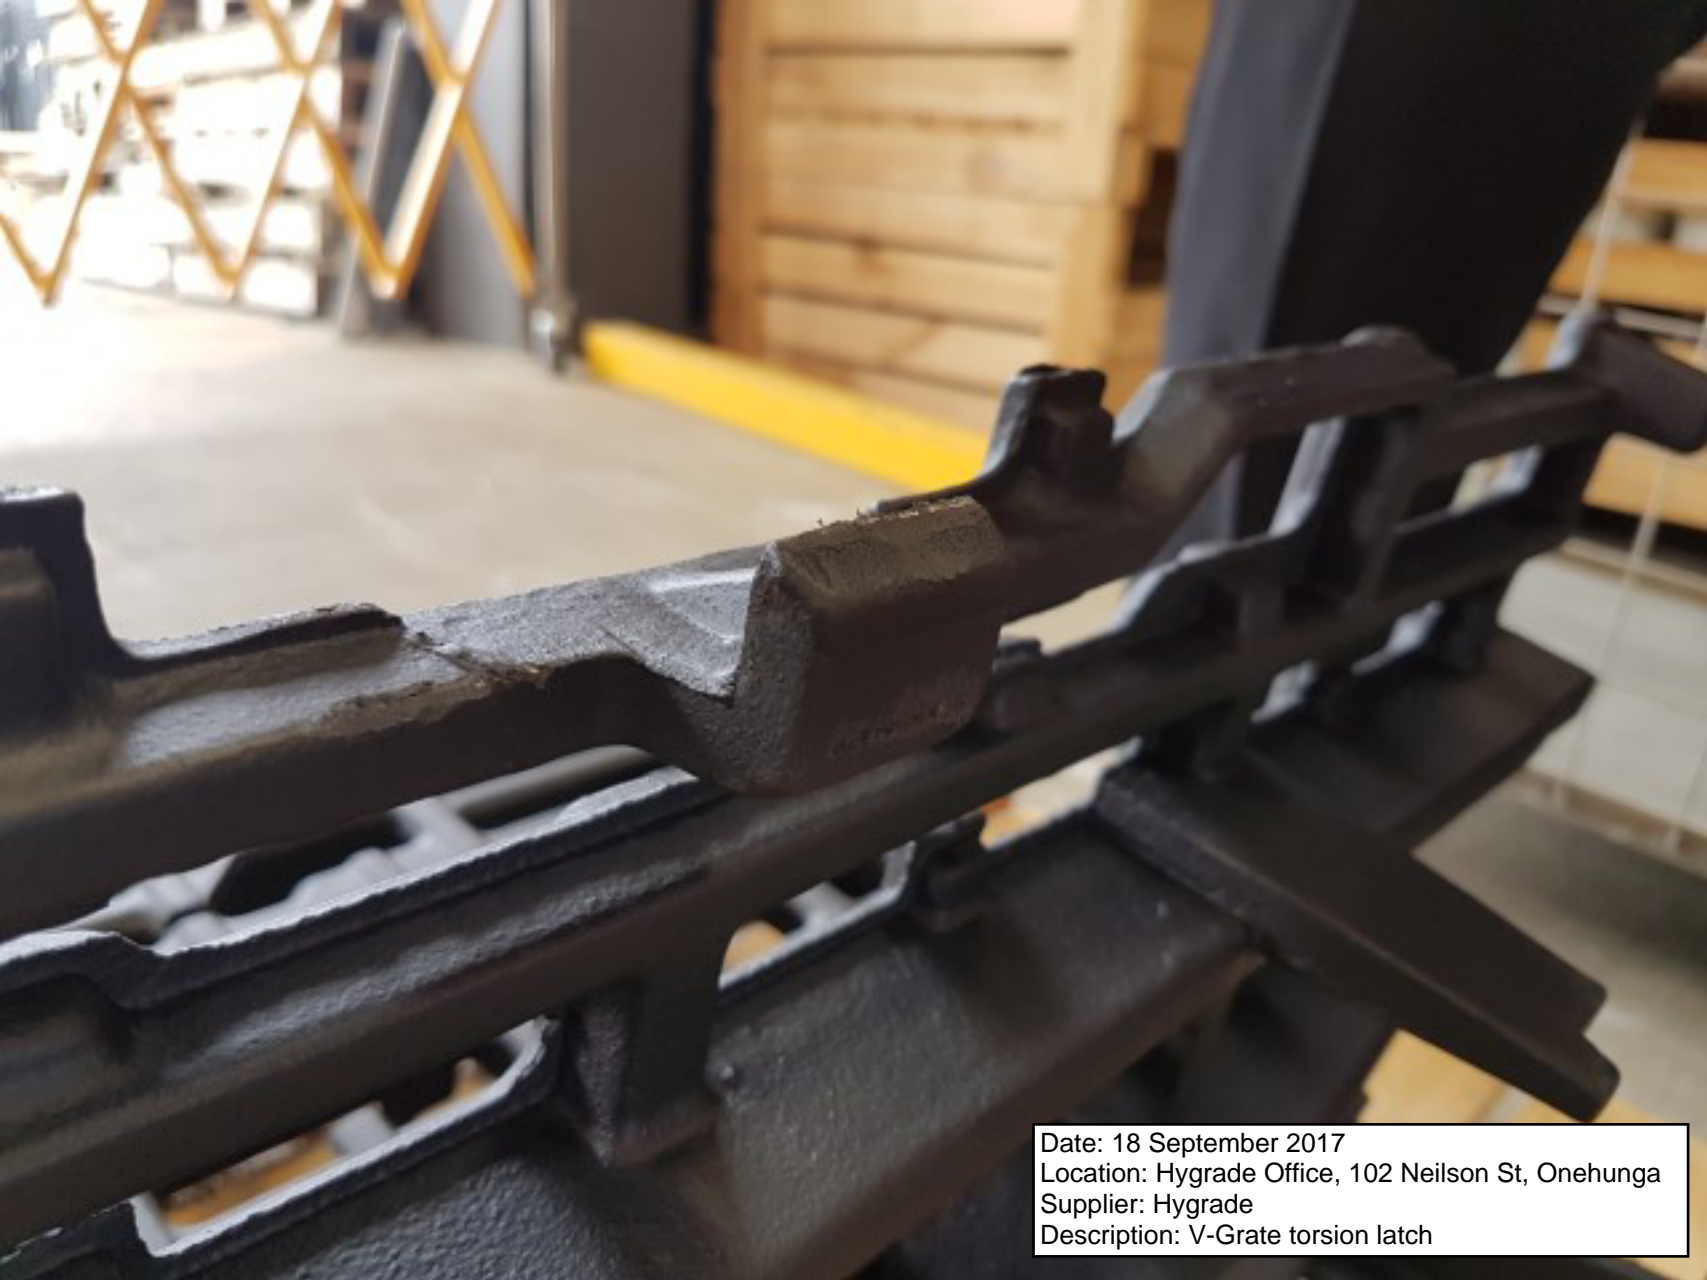
Date: 18 September 2017
Location: Hygrade Office, 102 Neilson St, Onehunga
Supplier: Hygrade
Description: V-Grate torsion latch
